REPORT SD-TR-83-36

Nondestructive Tests for Corrosion in Fuel Tanks

P. MAHADEVAN and P. BREISACHER
Aerophysics Laboratory
Laboratory Operations
The Aerospace Corporation
El Segundo, Calif. 90245

1 June 1983

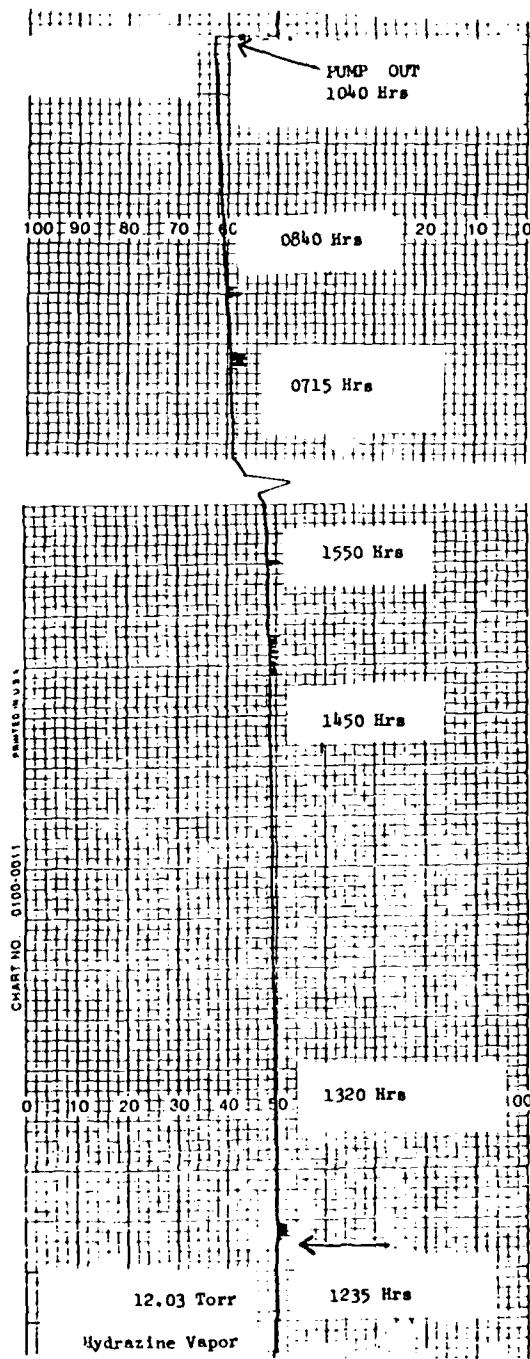
Fig. 4. Strip Chart Trace of Differential Pressure

The pressurant tank was conditioned with hydrazine, as discussed previously. After checking stability of the transducer system output, a test run with approximately 12 Torr of fuel vapor in the Freon chamber was started. The fuel side of the tank was pumped down and sealed off. A strip chart trace of a typical test run is shown in Fig. 4. The run lasted 23 hr. The differential Δp is estimated to be about 21 Torr. At the end of this run, the expulsion gas side of the tank was sealed off, and the whole system moved to the analytical laboratory. The residual gas in this side of the tank was analyzed with a Bendix time-of-flight mass spectrometer. Residual fuel was still found in the tank along with NH_3 , N_2 , and H_2 . Accurate quantitative estimates of the extent of decomposition of N_2H_4 are difficult to obtain with the analytical procedure adopted here. A clean reference tank with a few rusted test pieces was substituted for the fuel tank in a subsequent test run over approximately the same amount of time. The pressure increase recorded was almost one and a half times that for the tank. However, this confirmatory test cannot be used to estimate the extent of corrosion in the fuel tank assembly.

Several test runs were made subsequently confirming the presence of rust on the tank. The discoloration on the inner threads of the Freon port was later cleaned with isopropyl alcohol, and the tests were repeated. The tank still exhibited a signal indicating rust spots inside.
